Manhole Inspection Summary

Manhole # S09MM1039MH

Insp Date: **1/20/09 4:47 PM**

Location Address: **4901 DENMORE AVE**

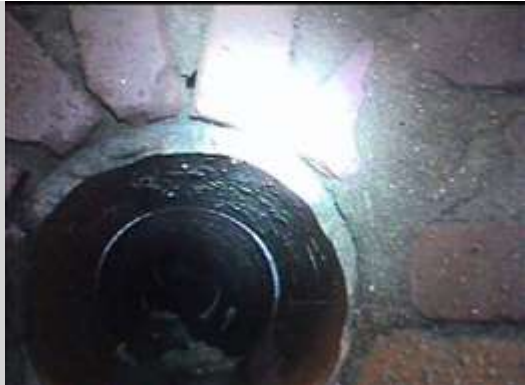
12 O'Clock Outflow

Pipe Height: (in.) Direct
Pipe Material: **Clay** ☐ Pipe Lined
Invert Depth: **10.29** (ft.) Flow Characteristics: **Slow**
Deposits: ☒ None ☐ Mud ☐ Sludge ☐ Debris ☐ Grease
Silt Depth: (in.) Deposits Extent:
Infiltration: **None** Pipe Seal Cond: **Sound**

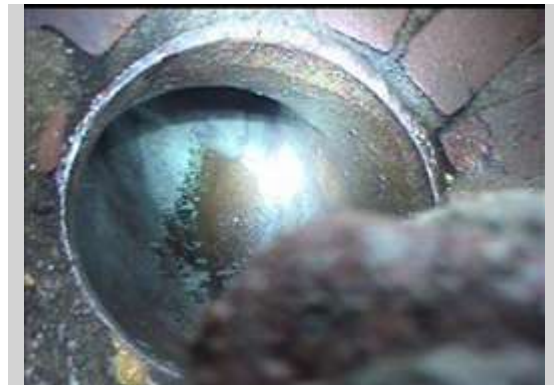
Drop In @ 3 O'Clock

Drop: **Outside Direct**
Angled: Reading: (ft.)
Inv Depth: **10.10** (ft.)
Drop Condition: **Open**

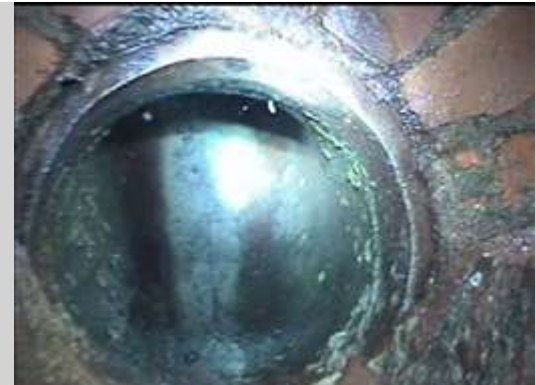
Drop In @ 5 O'Clock

Infiltration: **None** Pipe Seal Cond: **Cracked**

Drop Condition: **Open**
